Black River Falls Mine Restoration

Jackson County Iron Mine
Black River Falls, Wisconsin
Project Initiation Date: 1975
Project Size: 1,340 acres

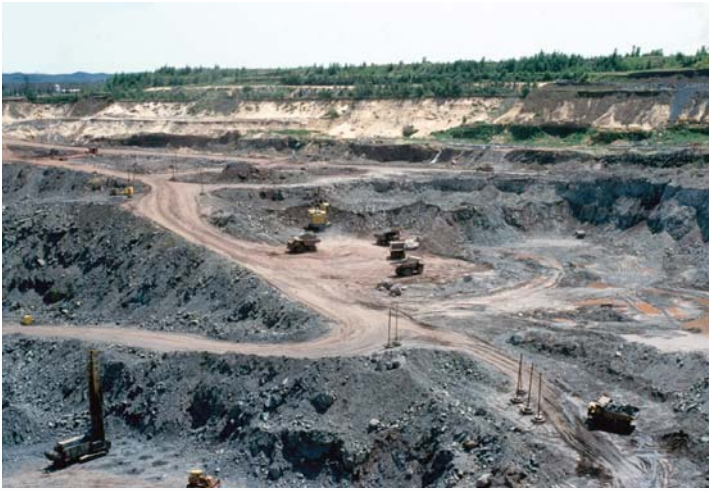
Black River Falls Mine Pre-restoration, 1977

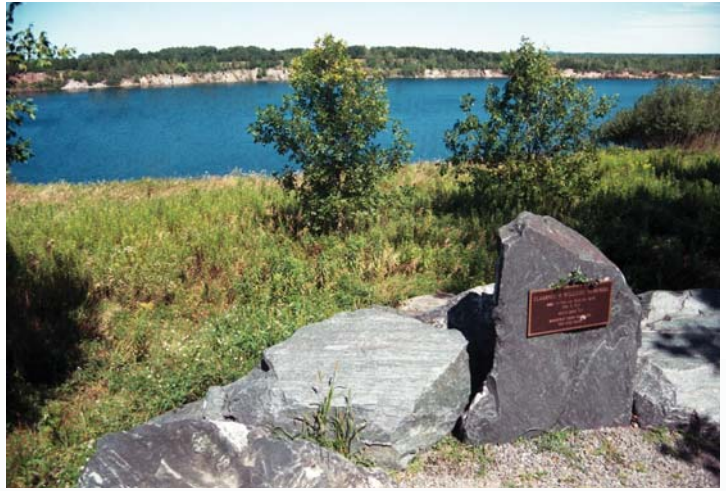
Black River Falls Mine Post-restoration, 1992
