John Deere Horicon Works

Horicon, Wisconsin

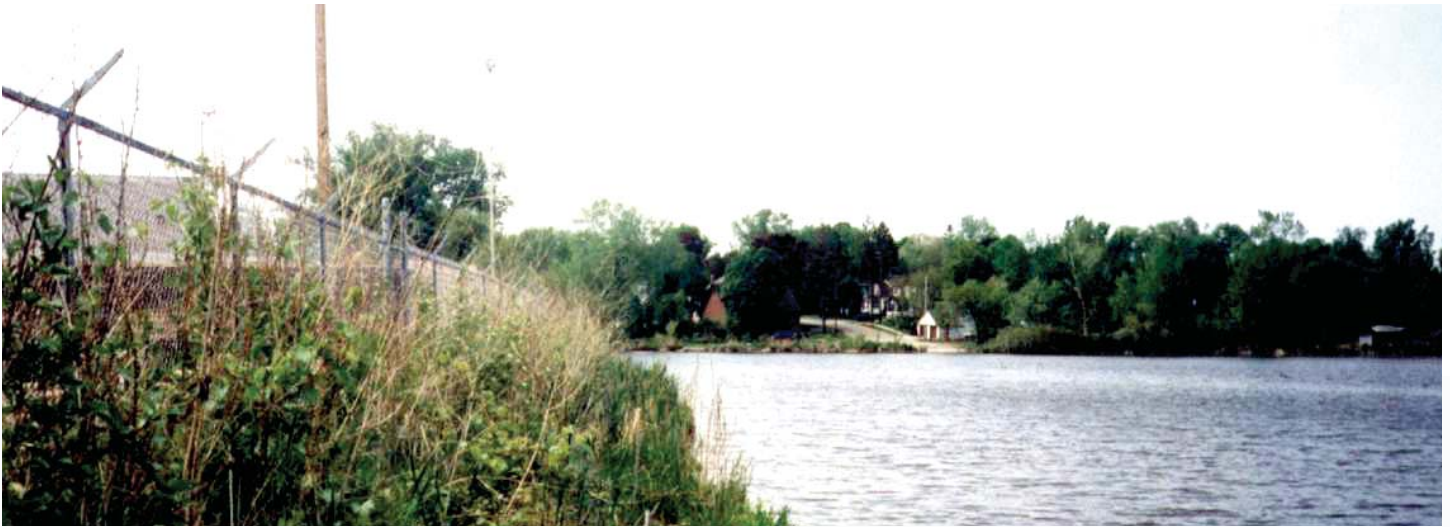
Riverbanks of the Rock River at John Deere Horicon Works in Horicon, Wisconsin, had become severely eroded and threatened to undermine storage facilities. Because of the site's proximity to the Horicon Marsh state and national wildlife areas, ecologically responsible treatments were prescribed.

Applied Ecological Services, Inc. completed two phases of construction and implementation of bioengineering treatments along the Rock River. Treatments ranging from coir (coconut fiber) rolls planted with native vegetation on a constructed toe to submerged flexible stone gabions with coir rolls and native wetland vegetation were utilized.
